**Flood Control Project Maintenance
Levee Inspections**

Fall 2013 Levee Maintenance Deficiency Summary Report

Levee Inspection Report By Mile - Fall 2013

Reclamation District No. 0755 Randall

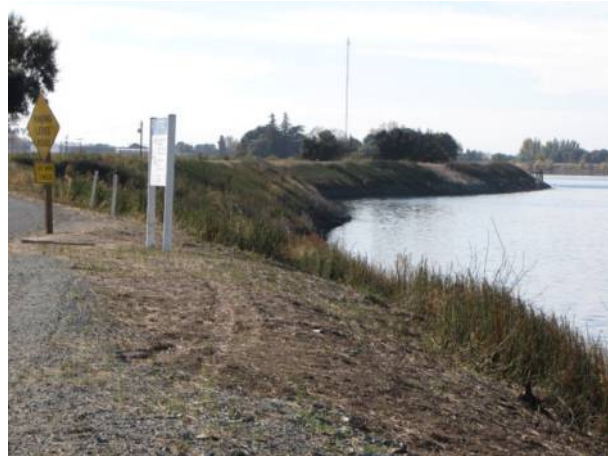
Levee Mile Report Line	4
Start Levee Mile	0.23
End Levee Mile	1.67
Location	Land Side
Category	Earthen Levee
Item	Vegetation
RD 755 Looking downstream from waterside shoulder. Photo taken 11-13-2013.	
phillips_f_20131202_746.JPG

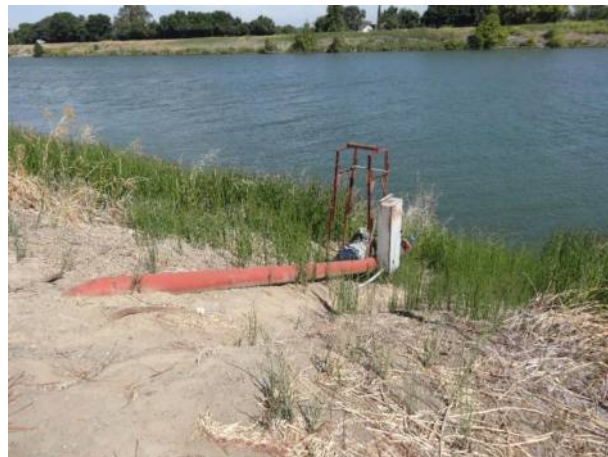
Levee Mile Report Line	8
Start Levee Mile	0.45
End Levee Mile	0.45
Location	Land Side
Category	Supplemental
Item	DWR UCIP Field Study
WS view: overview of pump and pipe.	
UCIP_9853.jpg

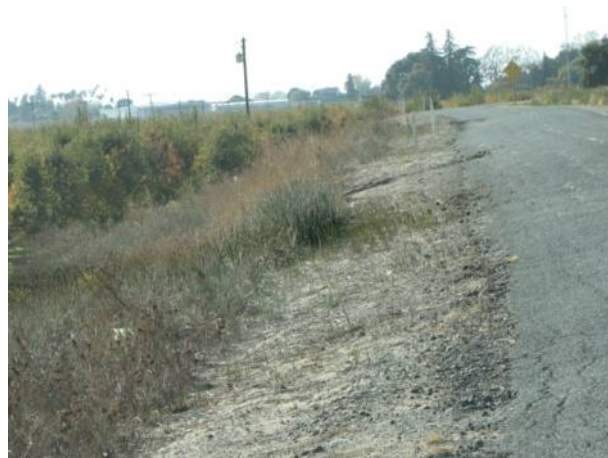
Levee Mile Report Line	10
Start Levee Mile	0.56
End Levee Mile	0.79
Location	Land Side
Category	Earthen Levee
Item	Vegetation
Weeds taller than 3-foot on landside slope. Photo taken 11-13-2013.	
phillips_f_20131202_747.JPG

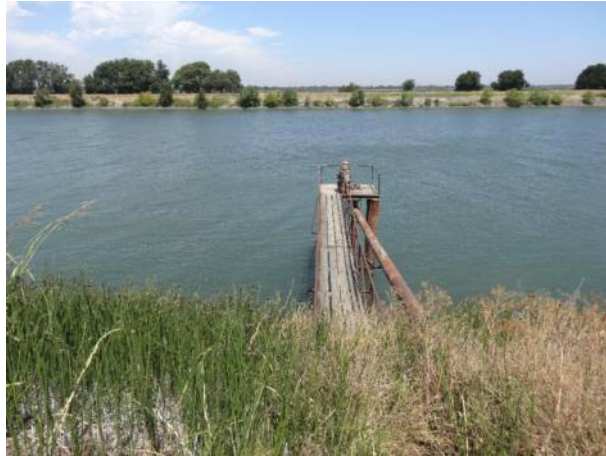
Levee Mile Report Line	11
Start Levee Mile	0.94
End Levee Mile	0.94
Location	Land Side
Category	Supplemental
Item	DWR UCIP Field Study

WS view: overview of pipe and pump structure.

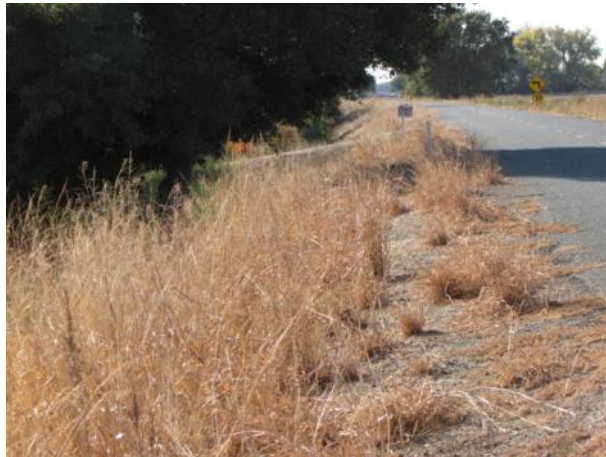
Levee Mile Report Line	13
Start Levee Mile	1.04
End Levee Mile	1.14
Location	Land Side
Category	Earthen Levee
Item	Vegetation

Weeds taller than 3-foot on landward slope and shoulder. Photo taken 11-13-2013.

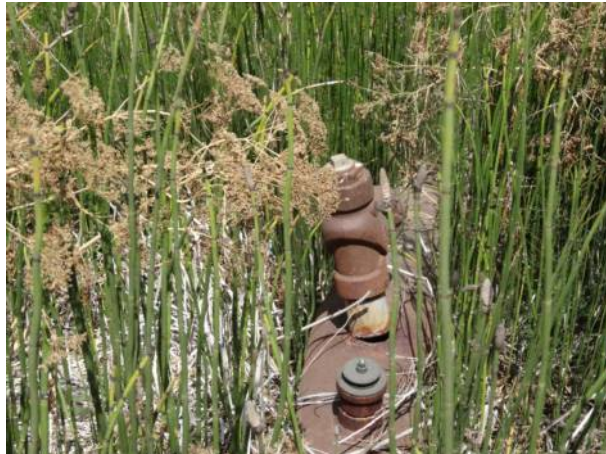
Levee Mile Report Line	14
Start Levee Mile	1.06
End Levee Mile	1.06
Location	Land Side
Category	Supplemental
Item	DWR UCIP Field Study

WS view: steel pipe with siphon breaker on levee slope

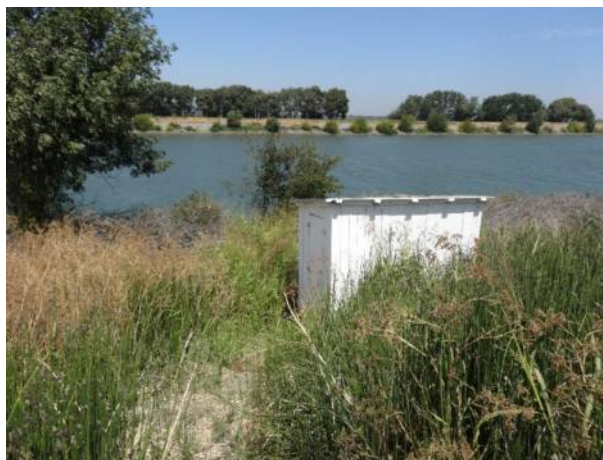
Levee Mile Report Line	18
Start Levee Mile	1.14
End Levee Mile	1.14
Location	Land Side
Category	Supplemental
Item	DWR UCIP Field Study

WS view: pump house on levee slope.

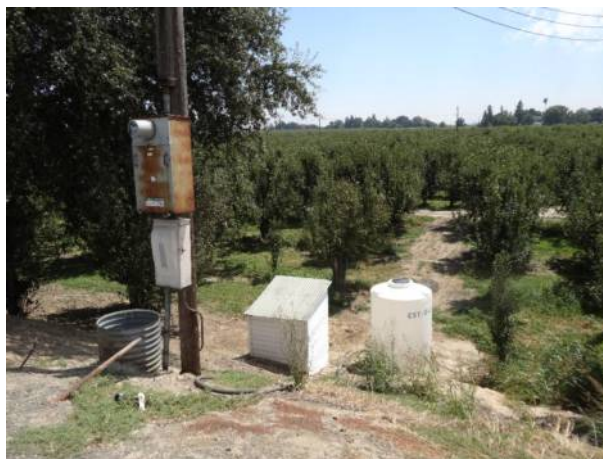
Levee Mile Report Line	24
Start Levee Mile	1.65
End Levee Mile	1.65
Location	Land Side
Category	Supplemental
Item	DWR UCIP Field Study

LS view: CMP riser, service pole, pump house like structure and an abandoned conduit pipe.
